ST. John The Evangelist Wembley Parish Church

REPORTS AND ACCOUNTS FOR 2022

QUINQUENNIAL INSPECTION • APRIL 2023 • REES BOLTER ARCHITECTS

**ST JOHN THE EVANGELIST, WEMBLEY
QUINQUENNIAL INSPECTION 2023**

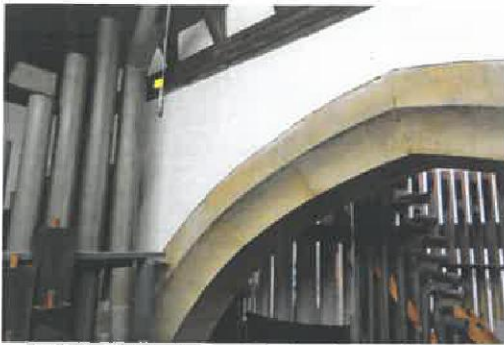
1. Archway between organ chamber and chancel.

- 2.1.4 Movement had occurred involving the settlement of the subfloor structures below the organ (photos 3 & 4), cracking in the archways between the organ chamber and the chancel (photo 1) and south aisle (photo 2). Cracking below the centre window of the south aisle had been noted before. Cracking above the door between the baptistery and south porch (photo 5) was evident during our inspection but had not been noted during the engineers visit.

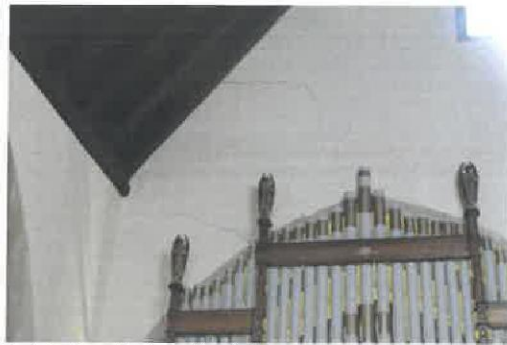
2. East end of south aisle.

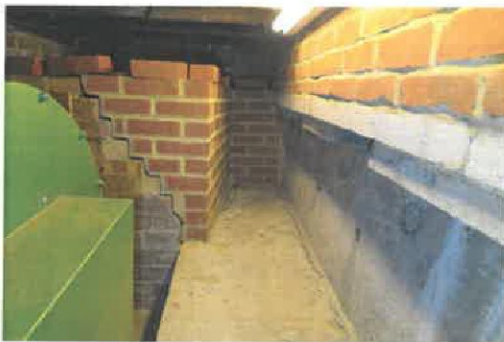
3. Chamber below the organ. Blower on the left. Settlement of ground supported structures.

- 2.1.5 The engineers key recommendations are:
 - a In the medium term the joists below the organ should be strengthened so that they do not rely on the sleeper wall, which is prone to further future movement, to support them at their midpoint. This could be done either by doubling up the existing joists or inserting a steel beam adjacent to the sleeper wall.

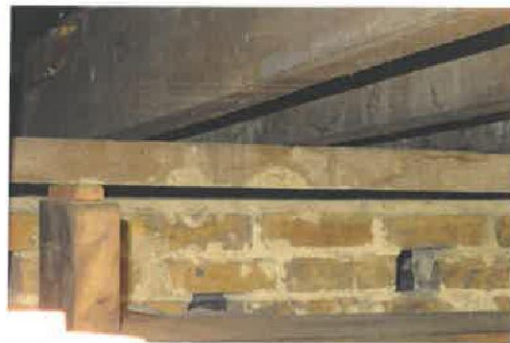
4. Gap appearing above the brick sleeper wall which no longer supports the joists above.

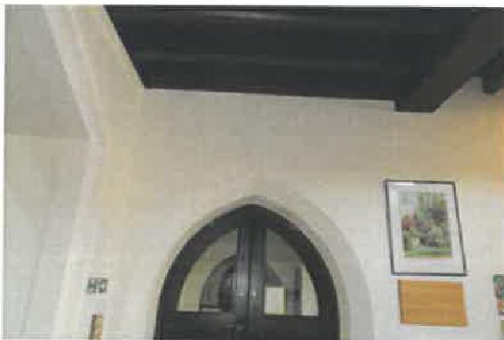
5. Recent cracking above door between baptistery and south porch.

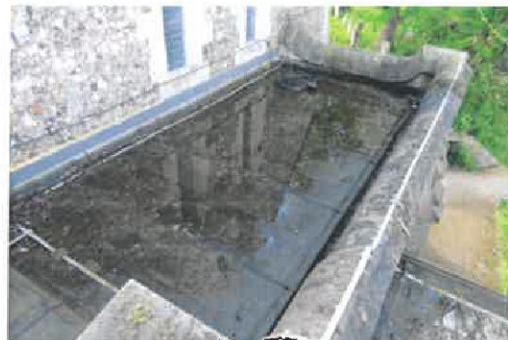
6. Ponding to small flat roofs.

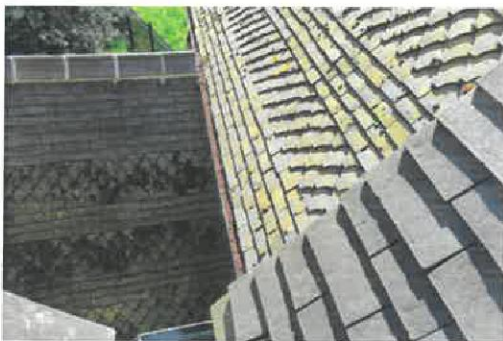
7. Blocked gutter to north side of chancel

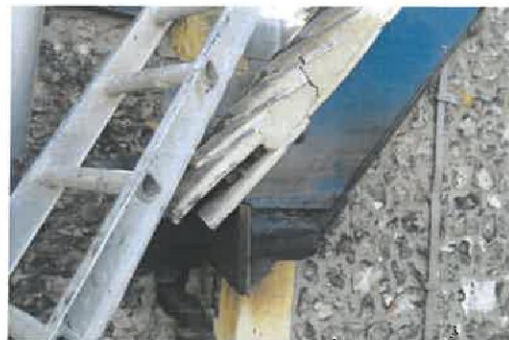
8. Access ladder damages the NW corner of the nave roof.

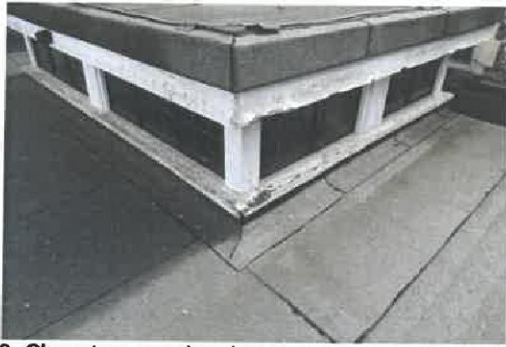
9. Clerestory over baptistery requires repairs to the cills,

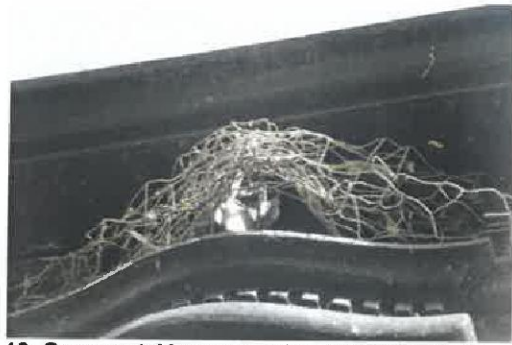
10. Ornamental hopper on the south side of the south aisle provides a nesting box for pigeons.

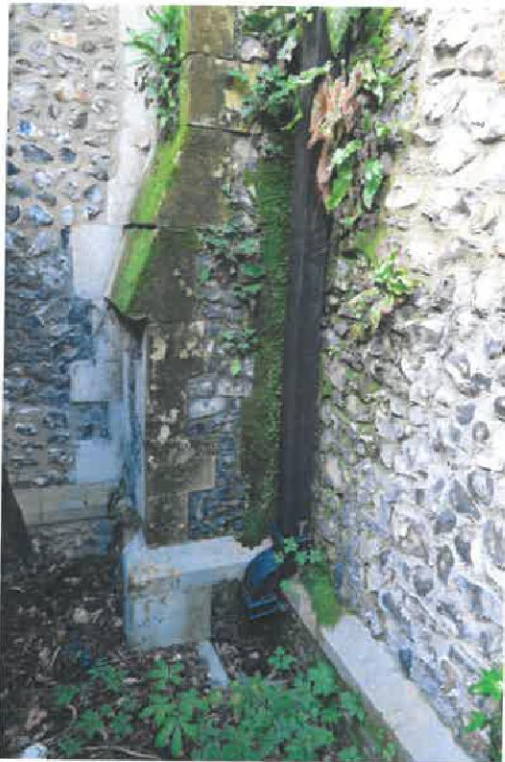
11. Saturated masonry of the buttress at the east end of the south aisle.

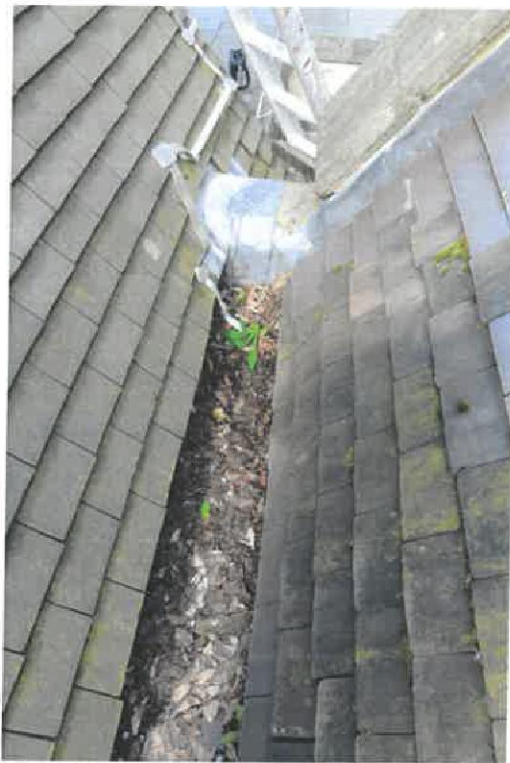
12. Leaf build up at the west end of the gutter between the nave and north aisle.

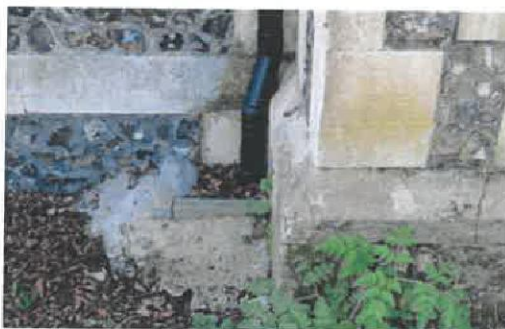
13. Gully to north aisle filled with leaves.

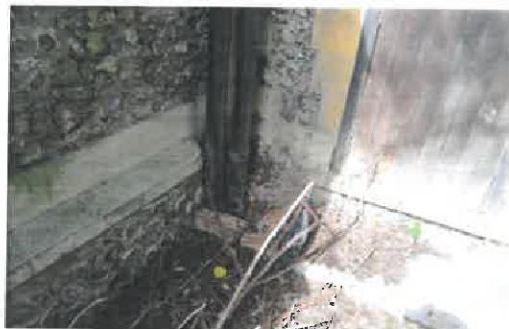
14. Gully to vestry filled with leaves.

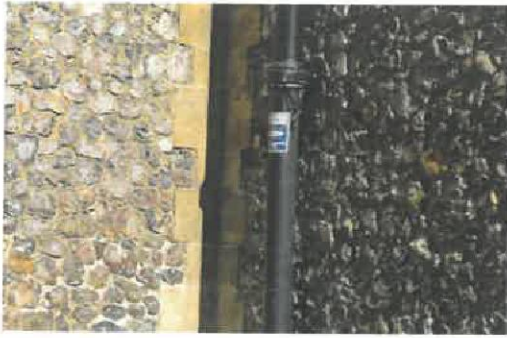
15. Cracked downpipe to south side of organ chamber.

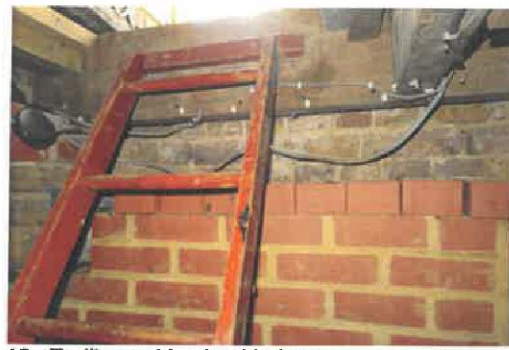
16. Trailing cables beside ladder to chamber below organ.

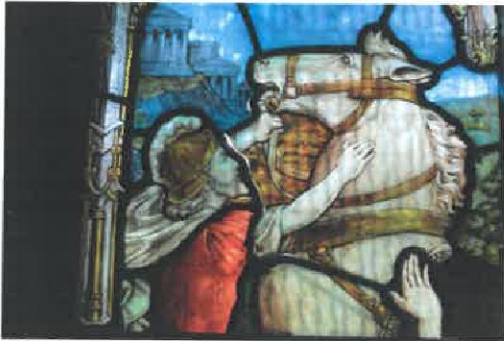
17. Gaps opening up in stained glass windows to south aisle.

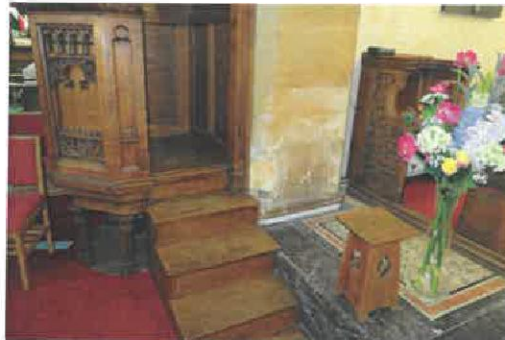
18. Evidence of saturated masonry behind the pulpit.

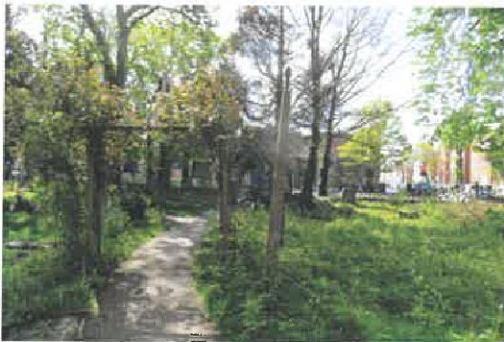
19. Churchyard path looking towards the lych gate.

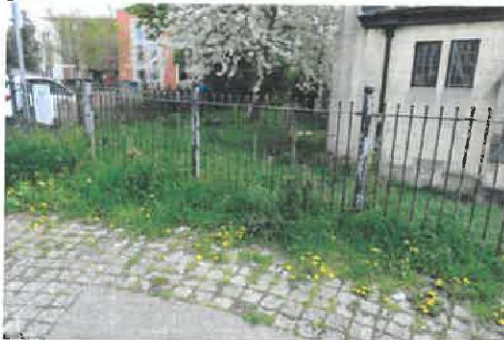
21. Railings to western boundary.

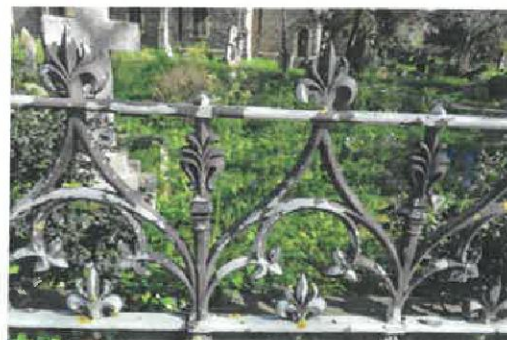
22. Peeling paint to front boundary.

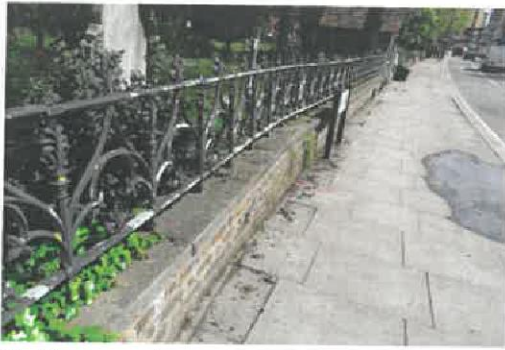
23. Movement in the front boundary railings.

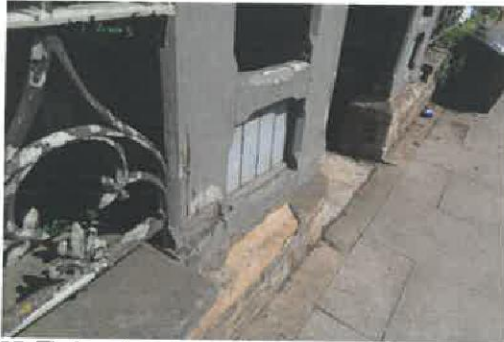
25. Timber decay to the exterior of the lych gate.

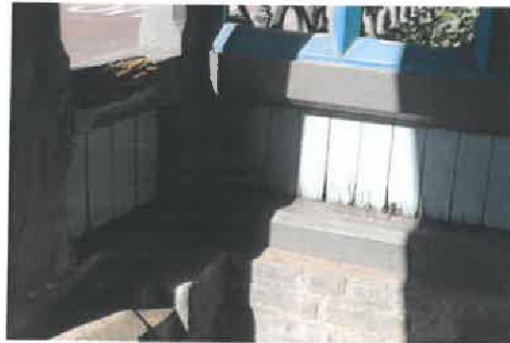
26. Timber decay to the interior of the lych gate.

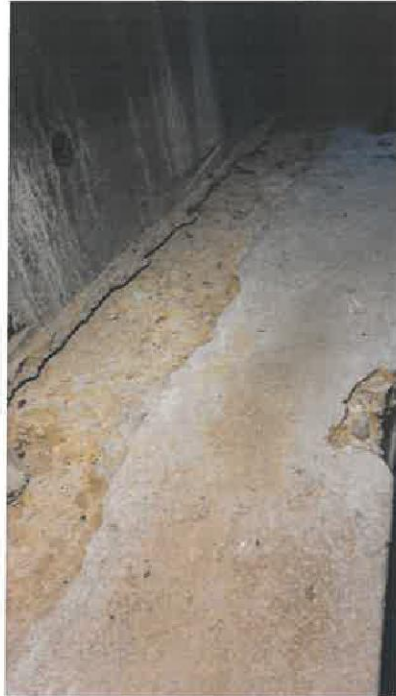
A number of recent areas of movement and cracking were identified within the undercroft. A number of cracks to the ground bearing concrete slab were identified.

Photograph 1: Cracking between the RC ground beam and ground bearing concrete upstand indicating differential settlement.

- c Desirable to infill gap between RC ground beam and the ground bearing concrete upstand with flexible filler
- d An arboricultuarlist should be commissioned to undertake a survey of the trees close to SE corner of the building and to make recommendations on management and/or felling to reduce the risk of future movements.
- e Management of the trees is likely to be more appropriate and certainly considerably less expensive than current and/or future underpinning costs.

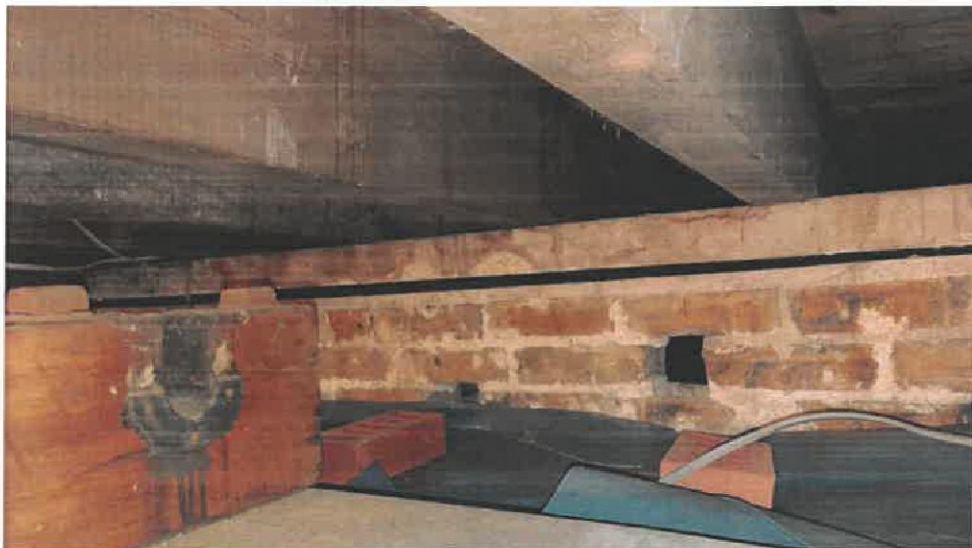
There was also significant settlement occurring to the internal sleeper walls. The main sleeper wall that supports the floor joists has settled to such an extent that the timber joists and wallplate are no longer bearing onto the wall and there is a large gap between the wall and timber plate.

Photograph 2: Sleeper wall has settled allowing a gap to form under the timber wall plate

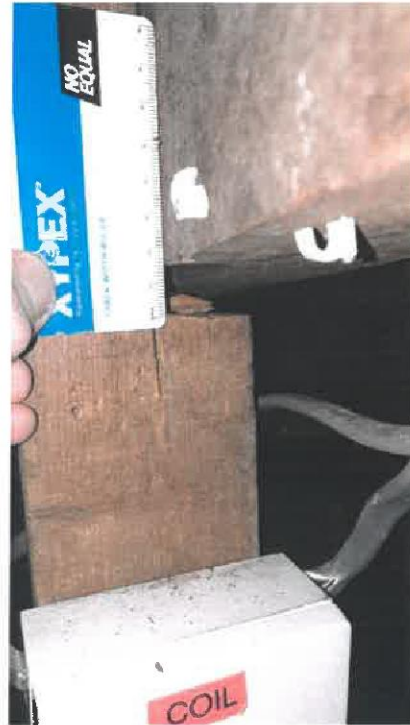
Cracking was noted to many of the sleeper walls (some of which do not provide support to the floor structure but an enclosure to the organ blower) and these walls have clearly dropped. In one location a timber post was notched and inserted between the underside of joist and an internal sleeper walls and the vertical movement recorded in this location was

Photograph 3: 15mm vertical settlement between timber post on internal sleeper wall and floor joist.

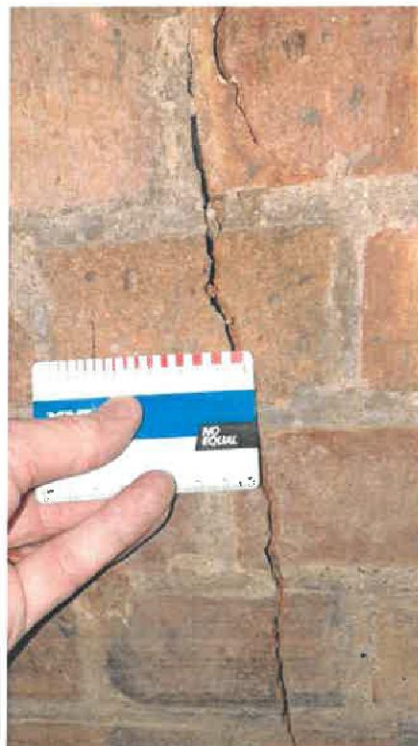
Photograph 4: vertical cracking to the internal sleeper walls to the undercroft.

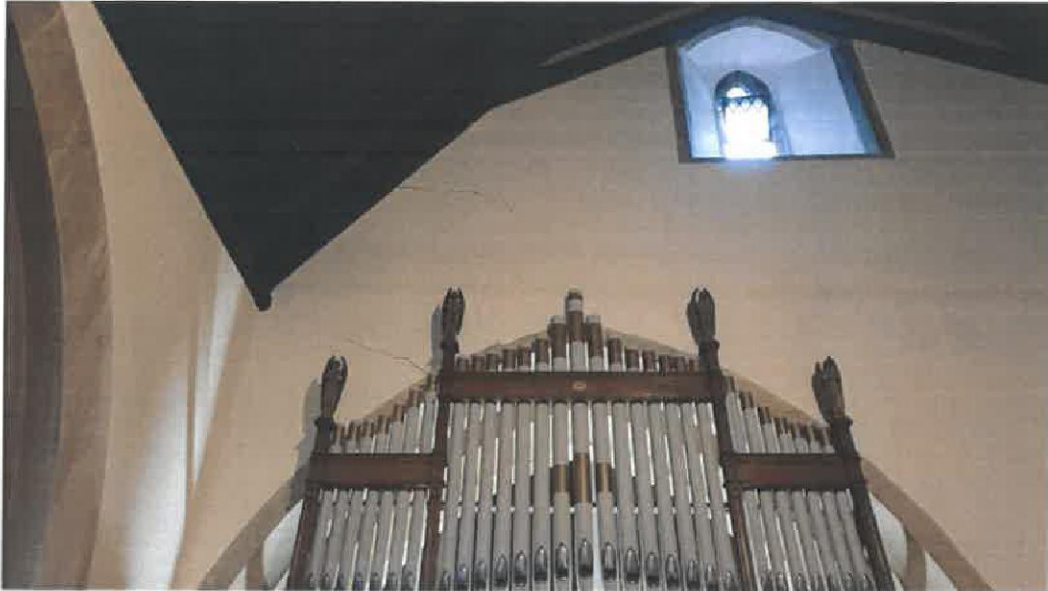
Cracking was also noted to the arch between the organ loft and south aisle. The cracking was on both sides of the wall. the cracking internally within the organ loft was to each side of the arch. It was also noted that a stone voussoir within the arch had dropped slightly.

Photograph 5: Cracking above the arch between the south aisle and organ loft.

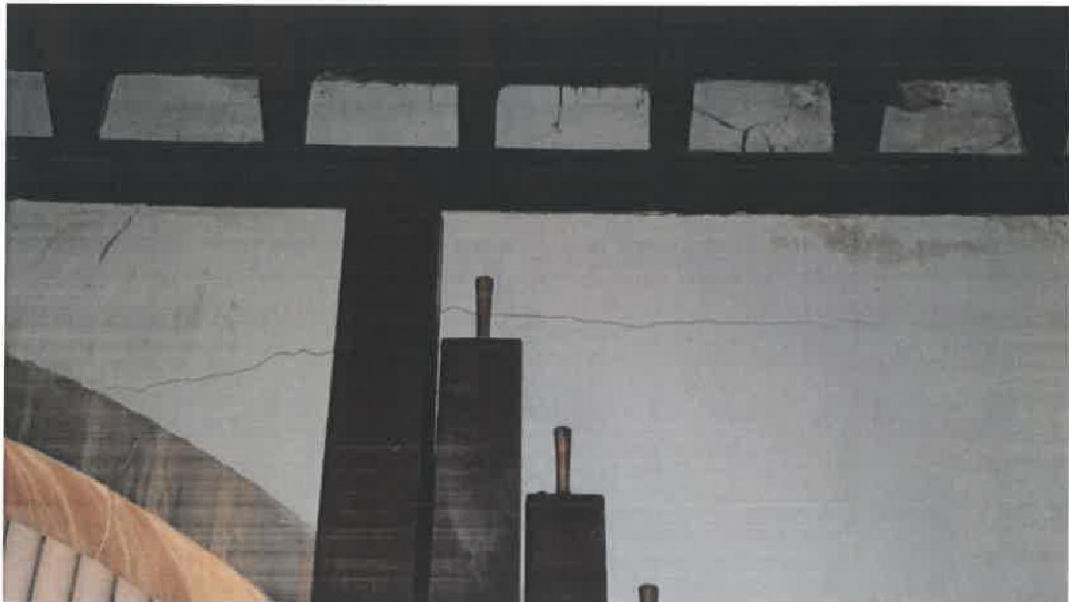
Photograph 6: cracking to south aisle wall from within organ loft.

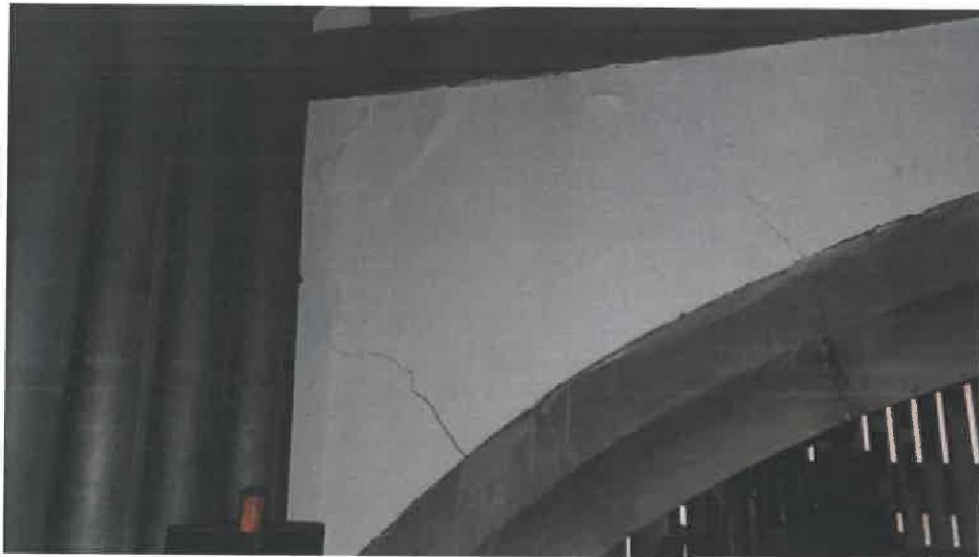
Cracking was also evident to the wall and arch between the organ loft and the chancel. Cracking could be seen on the chancel side of the wall however this was difficult to fully observe as this was concealed by the organ pipes. Cracking was also evident to this wall internally.

Photograph 7: Cracks from within organ loft of arch into the chancel area.

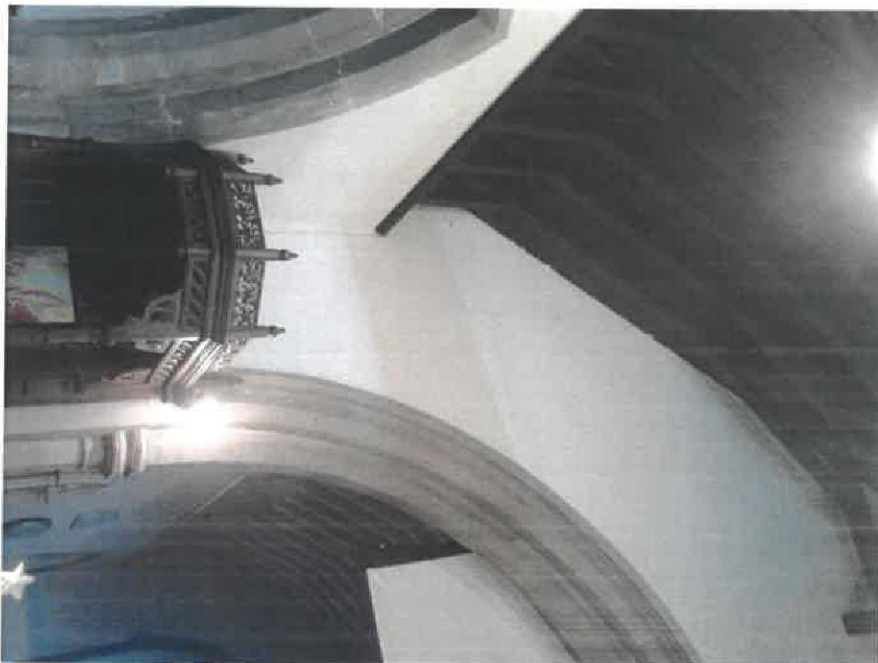
Cracking also exists to the north side of the Chancel arch above the pulpit. This could be related to the settlement of the south support wall of the arch.

Photograph 8: Cracking to the north side of the chancel arch, above the pulpit.

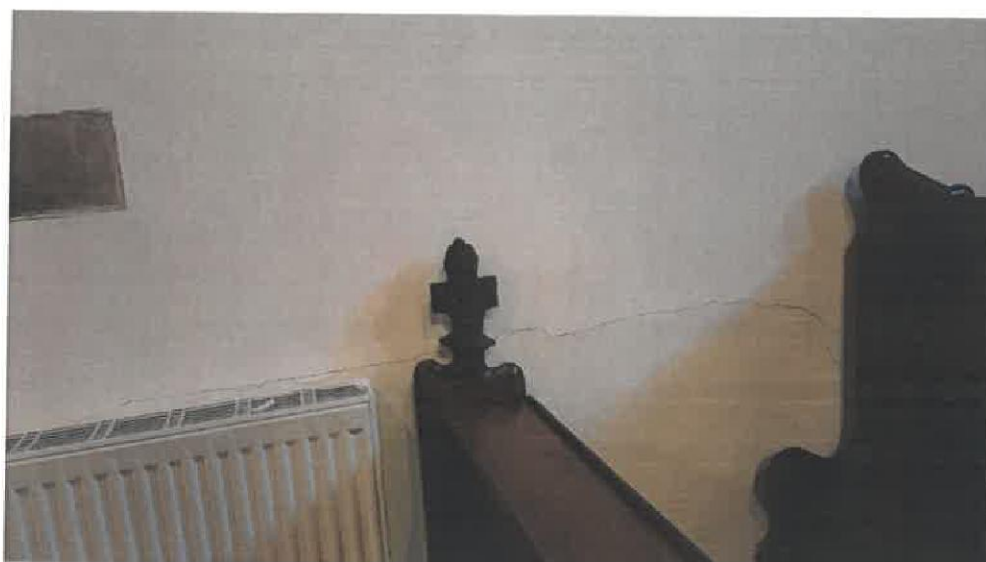
Additional cracking was noted to the external wall to the south aisle, approximately half way between the organ loft and entrance porch. This cracking was mainly horizontal and hairline in magnitude. This cracking is located close to the transition foundation beam that connects the section of the church that has been underpinned and the section of church that has not been underpinned. This cracking is to be expected as this is the location where differential settlement occurs.

Photograph 8: Horizontal cracking to north aisle external wall
